Reference No.1>
April 10, 2013
Future Plan for the Water Transfer from the Underground Reservoirs Tokyo Electric Power Company

Measures to Prevent the Expansion of Contaminated Water Leakage from the Underground Reservoirs

Cause Investigation of the Leakage from the Underground Reservoirs (Site Investigation of the Underground Reservoir No.2)

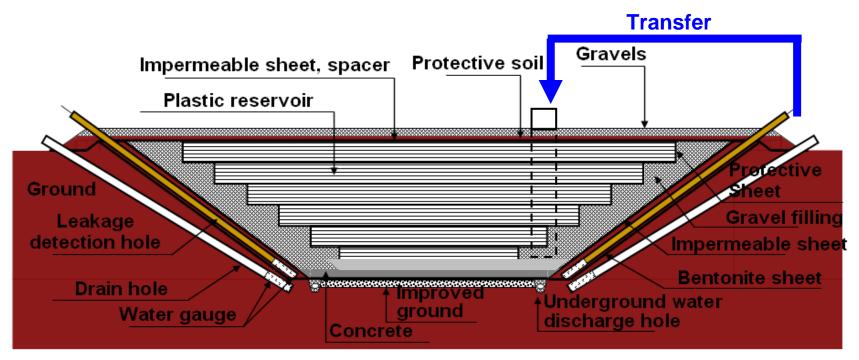
As a measure to be implemented for the time being (until the water in the underground reservoirs is emptied out), small pumps will be installed in the leakage detection holes to return the contaminated water to the underground reservoirs for the purpose of preventing the expansion of contaminated water leakage (The work to be started on April 10).

- Measures to prevent the expansion of contaminated water leakage
 - Currently, the contaminated water leaked from the underground reservoirs No.1 and No.2 is accumulated in the leakage detection holes.
 - In order to prevent the leaked water in the leakage detection holes from leaking into the ground in the surrounding area, the water in the leakage detection holes will be returned to the underground reservoirs.

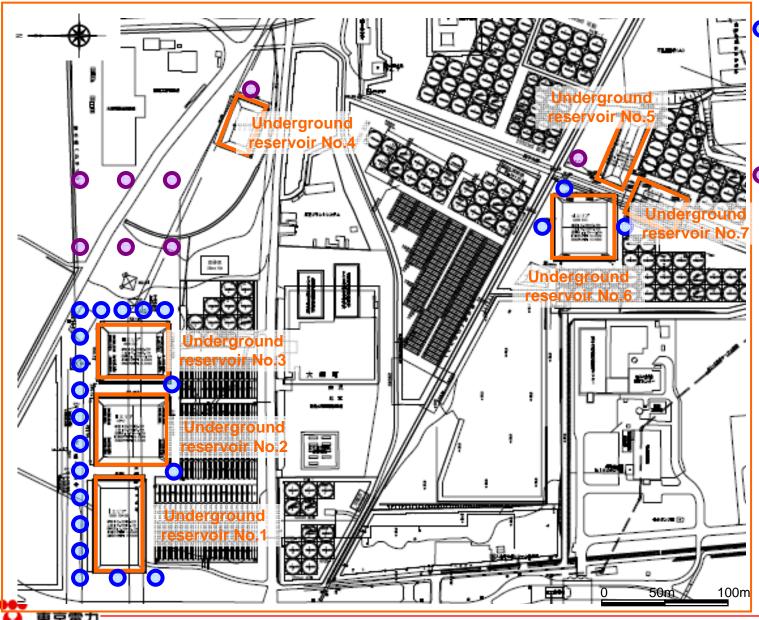
Investigation Locations (Details)

- New observation holes (at 22 locations)
 (Understanding the contamination condition in the surrounding area of the underground reservoirs)
 Depth: Approx. 5-15m
- New observation holes (at 8 locations)
 (Continuous monitoring for contamination expansion to the sea side)
 Depth: Approx. 20-30m

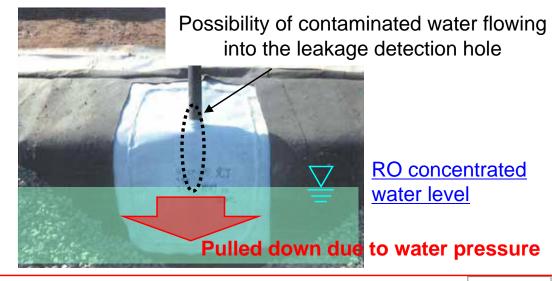
- Assumed cause
 - The problem with the leakage detection hole penetration is considered to be one of the possible causes.
 - There is a high possibility that the leakage occurred in the northeast side of the leakage detection hole where a high density of ray is detected.
- Investigation Policy
 - Visually inspect the conditions of the impermeable sheet and the leakage
 detection hole in the leakage detection hole penetration in the northeast side
 where the leakage is suspected.

Damaged due to the welding area being stretched
